# Infrastructure Inventory Memo

Spruce Street San Marcos Texas 78666

| <b>SUBJECT</b> | Community Infrastructure Roads and Drainage |

**Purpose.** Visual Inspection of storm water infrastructure, drainage and road repairs. Documenting the existing conditions prior to upcoming scheduled repair.

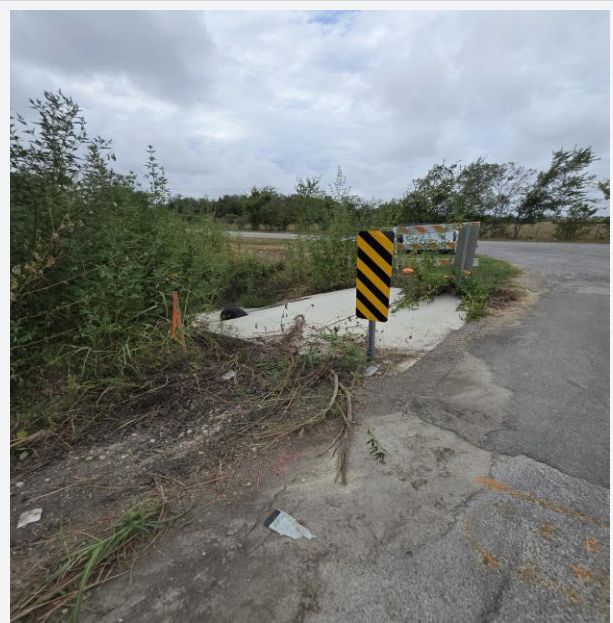
Figure 2. Right Side Storm Drain Path Recently Installed .

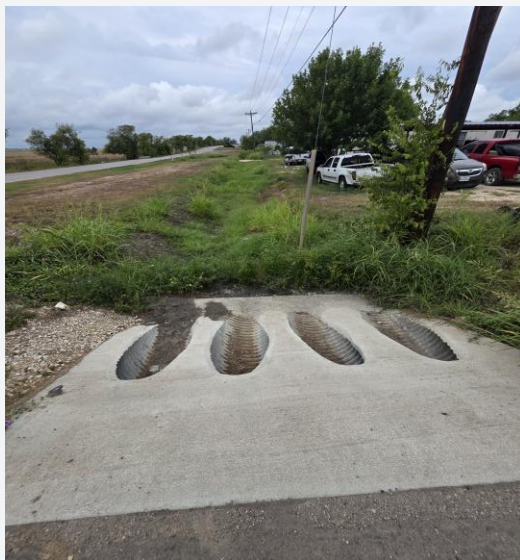
Figure 3. Left Side Storm Drain

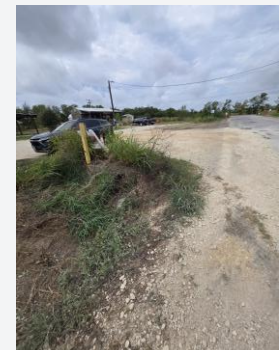
Centro Esperanza Storm Drain  
Brush  
Storm Drain Outlet Overgrown  
Left Side

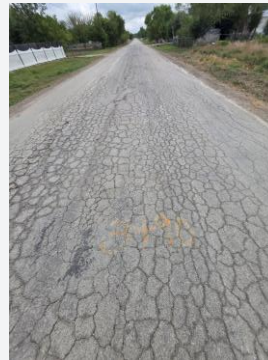
The conditions of the roads had visible damage cracking, surfacing potholes, minimal to tight shoulders.

Figure 9 Spruce Street Existing  
Road Conditions Cracked  
Marked 3+90

1. Repair Roads- Continue to improve the roads as scheduled. Follow up inspections and maintenance.
2. Lighting- Review the lighting and visibility in the area for overall pedestrian safety.
3. Improve safety and accessibility- For pedestrian safety is important to include warning signs, crosswalks, and waiting areas for k-12 students waiting for this bus.
4. Storm Drain Maintenance Upkeep and Maintenance on the storm drain areas remove heavy debris and shrub. Monitor during heavy rains to ensure system is working correctly.
5. Coordinate future infrastructure projects and proper communication with surrounding areas and members such as the City of San Marcos and Redwood Vista WSC to ensure the community has access to the necessary needs and support. Inform the public about upcoming works
